Marine Safety Flash

A14-03 (3rd June)

Sling failure while lifting Yokohama fender

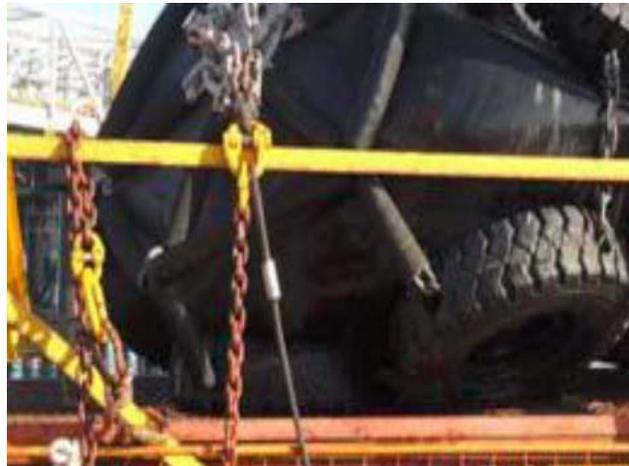
Whilst preparing to move the barge closer to the Jetty work site, it was identified that 3 Yokohama fenders required relocation from the water on starboard side of the barge to their holding cradles on the barge deck. The fenders had a pre-rigged sling arrangement fitted. This consisted of a wire sling shackled to each end of the fender running to a central hammerlock shackle with a 3 tonne SWL, 3 metre long 'Superflex' sling rigged for the crane hook off this.

- Leaving slings fitted to equipment, where inspections of those slings is difficult shall be avoided
- Contactors to audit all lifting gear at regular intervals to ensure it is on a register, compliant with project requirements and discard all rigging gear that is not compliant or damaged
- Rigging personnel are re- tested to ensure competence with inspection and with rigging techniques.
- Company rigging and lifting personnel conduct regular inspections of rigging registers and rigging gear at worksites
- The roles and responsibilities of Supervisors in relation to supervising their personnel must be clearly stated and enforced

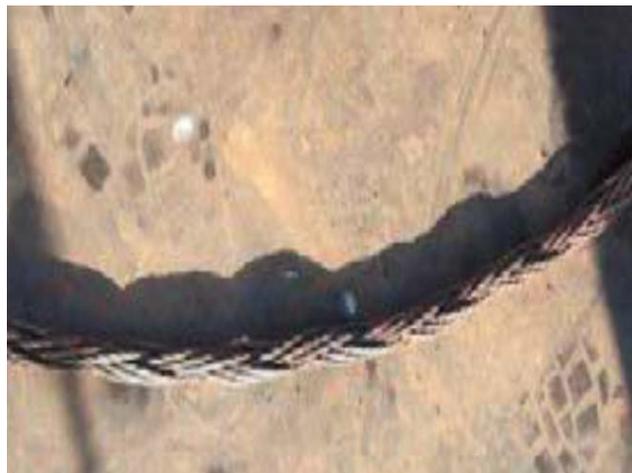
During the lifting of the 2nd fender, while the fender was between 2 and 5 metres above the holding cradle, the Superflex sling failed, causing the fender to fall, contacting a vertical post on the fender holder. The fender's structural integrity was compromised, causing the fender to deflate. The fender came to rest in the holding frame.

The weight of the fender exceeded 3 tonnes.

- The failed wire sling did not have the required identifying marks, test dates or SWL stamped on it
- The wire sling was in a poor state visually
- There was no record of sling inspections located
- The rigging set up for the lift was not an approved method of rigging: - the main sling and the 2 Superflex slings were joined by a hammerlock fitting.
- The failed rigging gear was left 'in situ' on the floating Yokohama fenders, making inspection and preventative maintenance difficult.
- Riggers had failed to identify the poor condition of the sling and that the weight of the load exceeded the SWL of the sling
