Marine Safety Flash

A14-07 (15th July)

Severe Hand injury – Rotating Machinery

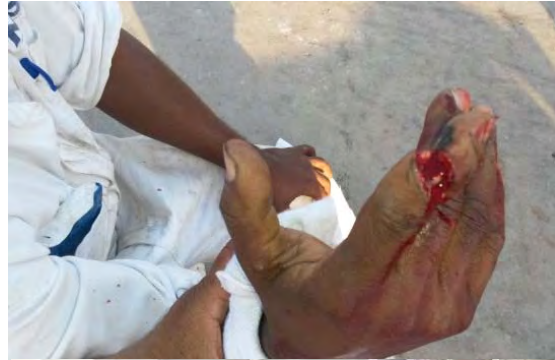
A newly installed generator was started without belt guards in place. The IP's finger got caught by the V-belt which resulted in fracture and deep laceration to the index finger. The potential could have been loss of finger/hand.

- Guards not in place.
- Lack of Risk Assessment, Permit to Work and Tool-Box talk.
- Lack of lock-out tagging of machinery.
- Lack of management assessment and involvement in non-routine job.

- Risk Assessment, Permit to Work and Tool-Box talk are carried out
- Tag out machinery without safety equipment in place
- Inspect and install safety guards before start up
