Marine Safety Flash

A15-02 (15th February)

Employee hit in face by projectile

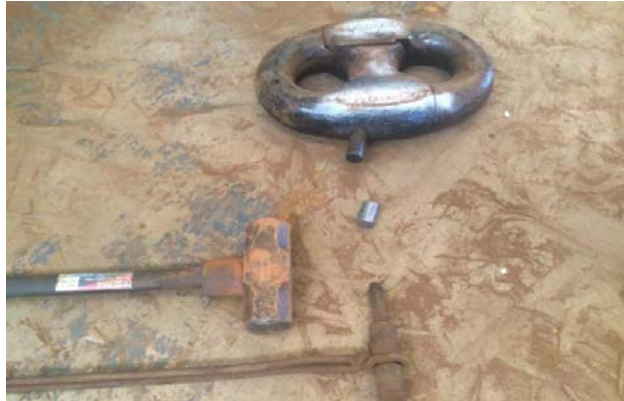
Whilst walking to the gangway to exit an Anchor Handling Vessel, IP was struck on the cheek by a projectile. This occurred Approx. 10 – 12 metres from where any work was being performed. The work being performed at the time was: 2 x vessel crew were hitting a lead plug into a kenter-link with a steel sledgehammer.

- There was no cleaning or flushing of the wound, nor was there any covering applied it post event.
- This task had been completed 14 times already during the shift for this deployment.
- Safety glasses, hard hat, steel cap boots, long sleeves and pants were worn at the time

Large hammers are ok for the initial impact to 'lock' in the lead plug however smaller size hammers (4Lb) to be utilised when finishing the hammering of the lead plug into the pinhole.

- Review task risk assessment and ensure it is up to date.
- Use 4lb hammers (only) for completion of hammering in lead plugs
- Communicate with all employees to ensure they monitor and maintain safe systems of work while completing tasks and to report incidents even when considered minor to leaders.
- Share lessons learnt with Anchor Handling Vessel HSE teams
- Operator is trialling using mobile barricades to demarcate area to minimise the risk of projectiles hitting bystanders.
