Marine Safety Flash

A15-08 (15th April)

Scaffold Ladder's damaged during Pipe Discharge

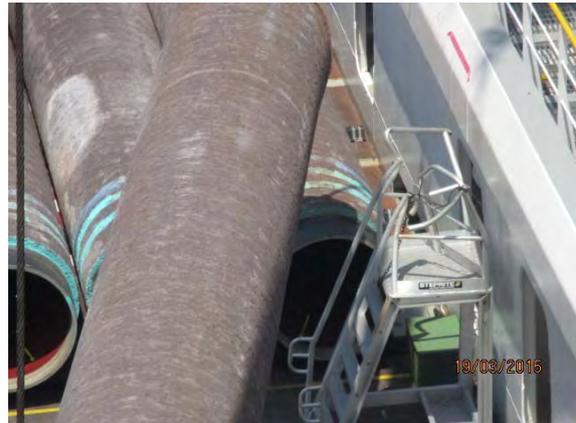
Vessel was carrying out line pipe discharge alongside Pipe Lay Vessel (PLV). During a lift from No.1 bay bottom tier the lift was observed to have an uncontrolled swing motion for a short period of time. It is assumed the PLV crane operator brought the pipe lift over towards the port crash barrier to stop the swing motion. Whilst this action was carried out the lift struck the scaffold ladder between bay's No. 1 and No. 2, then swung into the second scaffold ladder situated in bay No. 3. This caused damage to the 2 scaffold ladders to an extent that they were quarantined.

Uncontrolled Pipe Swing

- Establish communication guidelines with crane operator to follow vessels directions while dogging.
- Reiterate all possible scenarios for an uncontrolled lift. Safety is 1st priority keep clear, reinforce above points during toolbox talks.
- Move ladders to the opposite side of the vessel that is likely to be out of the line of fire for an uncontrolled lift.
- Crane operator to be made aware of the load swinging and the boom to be swung around at a slow speed during cargo operations.
- The dogman should be placed in the safest position on the vessel and (if possible) at right angles to all lifts so he can see when the PLV crane boom is directly over the lift before lifting.
- During discharge of pipes, the slinging of pipe to be carried out only after crane boom is aligned with the pipe.

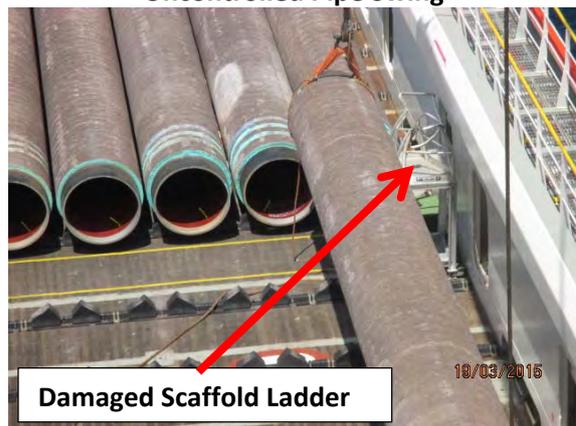
Damaged Scaffold Ladder
