# Marine Safety Flash

## A15-15 (15<sup>th</sup> July)

### Finger Pinch Injury

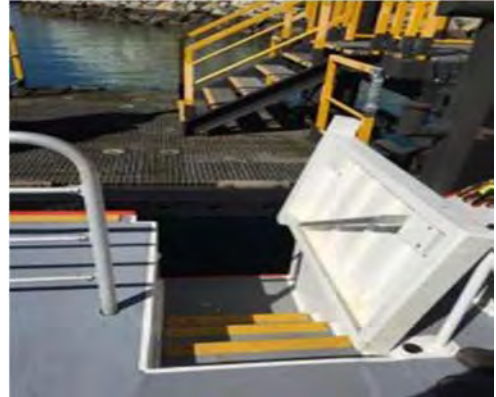
IP was undertaking vessel transfer from Crew Transfer Vessel to Accommodation Vessel Fast Recovery Craft (FRC). As the IP disembarked from the CTV, holding onto the transom hatch cover, the unsecured cover fell onto the IP's finger, on their right hand, causing injury. The IP was wearing appropriate gloves at the time of the injury.

Pinch Point

- Is risk assessment appropriate/ adequate and are being followed?
- Ensure that hardware is fit for purpose e.g. latching mechanism

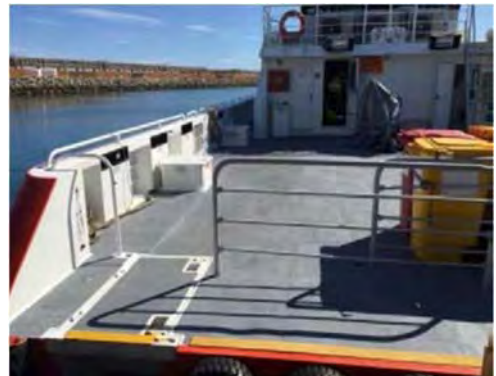
Cover in closed position

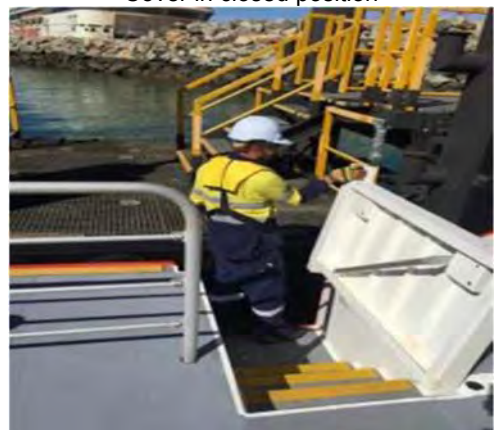
Re-enactment
