Marine Safety Flash

A15-33 (15th December)

IP Sprains Ankle Removing Chain from Drum

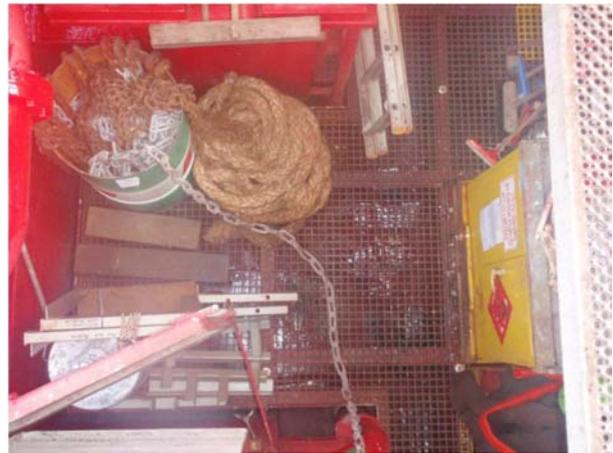
The IP positioned himself with his right knee resting on a section of old coiled mooring rope next to the 44 gallon drum and his left foot lay flat on the deck grating. When the IP stood upright with the chain in both hands, he felt a twinge / pain in his left ankle / foot region. The left ankle was not rolled and there were no uneven protrusions on the deck in the immediate work area. The injury was later diagnosed as a sprain with no bone, tissue or ligament damage.

Photos 1: The view of looking down on chain storage drum

- Poor Posture – Due to the posture of the IP when removing the chain from the drum and transferring his weight to his left leg, it caused over exertion in the left ankle.

- Poor housekeeping – Due to the mooring rope been used previously it was coiled and stored at the most convenient location. If the mooring rope was not there the IP would not have knelt down to retrieve the chain.

- Accessibility to the lashing chain was poor in that it was not readily accessible due to the mooring rope not providing appropriate access to the lashing chain in the drum.

1. Review and discuss this incident with all crew on board at next Safety Meeting.
2. Reinforce good housekeeping practices.
3. Reinforce in risk assessment/toolbox meeting, the correct manual handling techniques to be used for the task.
4. Inspection to be carried out on board where any mooring rope that is used on the deck to prevent steel on steel contact should be hung up/secured in a suitable location on deck e.g. on the outside of the crash rails.
5. Crew to be reminded to Stopping the Job when an injury occurs during a task to seek treatment at the earliest opportunity.
6. PPE Matrix to be reviewed by HSEQ department to identify the correct type of safety boots to be worn to ensure that they have adequate ankle protection.
