Marine Safety Flash

A16-05 (5th February 2016)

Potential Dropped Object

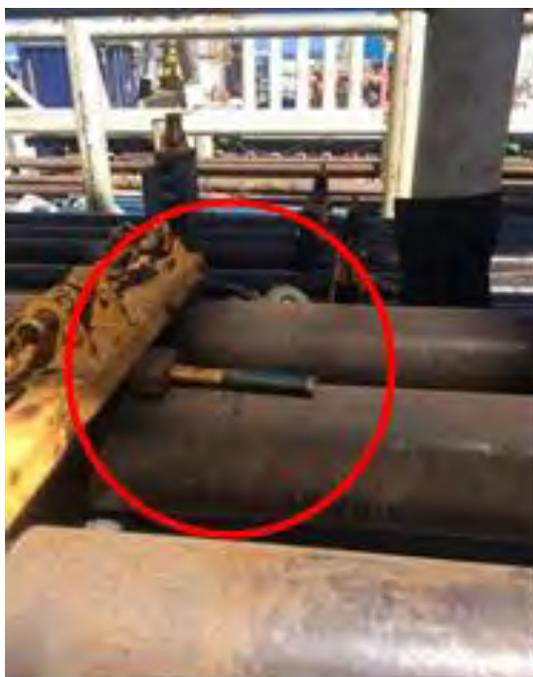
Picture 1 - Lump Hammer left on rack

P1 then placed the lump hammer on the drill pipe in one of the racks and continued to remove the lashing chain from the drill pipe and the crash rail – See picture #1. Shortly after, tag lines were lowered to the deck by the port crane to subsequently lift the rack. P1 and P2 attached the tag lines and secured the load. The lift then commenced, the crewmembers moving into a safe area prior to the lift.

The rack was landed safely on the rig. A few minutes later P2 was informed via the crane driver on the VHF radio that a lump hammer weighing 2.1kgs had been left on the rack. P2 had the VHF radio and apologized for the oversight. P1 and P2 continued the operation and all other cargo was discharged without incident.

- Risk Assessment (RA) for Loading and unlashng cargo were discussed in detail prior to the task.
- Dropped objects were not considered / captured as a hazard
- Assessment for Dropped Objects is a separate document and was not considered at the time.
- There was no visual inspection of the load or the lifting arrangement prior to the lift.

- Review cargo operations process to include potential dropped objects
- Review Dropped Objects Procedures and Best Practice Documentation and discuss with Crew at next safety meeting
