Marine Safety Flash

A16-10 (11th March 2016)

Slip on stairwell during off duty time

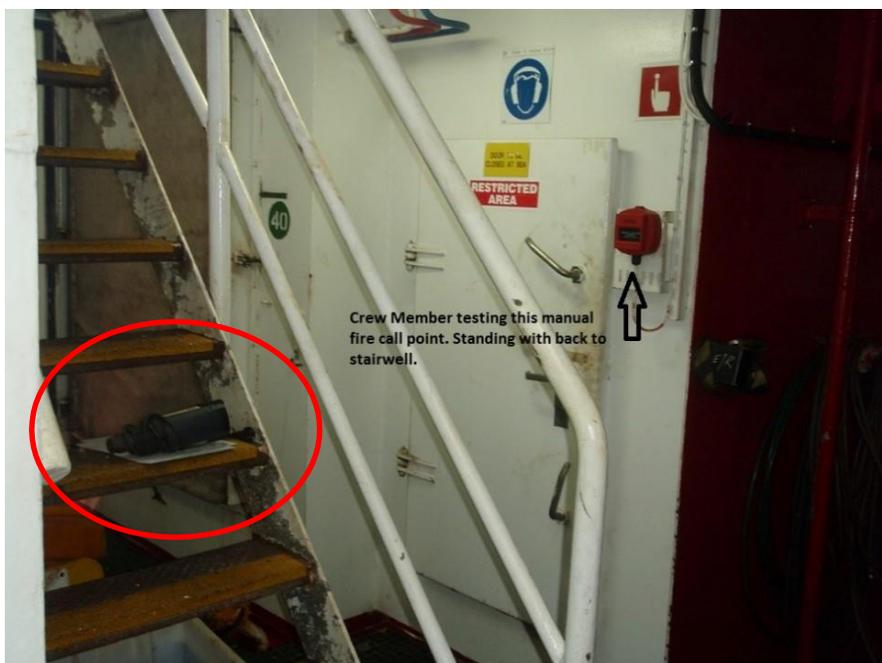
- The subsequent on board investigation found that a crewmember placed the hazards on the step tread. This was due to him testing the manual fire call points adjacent to the stairwell (standing with back to the stairwell). The crewmember did not perceive this as a hazardous situation as he believed there were no “blind spots” where he was standing.
- The IP was off duty at the time. He was walking around the vessel from main deck up to forecastle and back. He had transited the stairwell approx. 6 times in the preceding half hour (approx.) before the incident occurred.
- The IP was descending the stairs with three point contact but unfortunately he was looking ahead rather than down the stairwell.
- The IP was wearing prescription sunglasses at the time; the heat gun was dark navy blue, placed on a black step background has been perceived as a contributing factor.

Photo 1 – During onboard investigation, the photo is taken about the same time when the incident occurred to demonstrate the lighting at the time.

- Safety Officers and Safety Representatives to discuss this incident with all crew at next opportunity to reinforce the importance of adequate Risk Assessment before any job. In particular, for the safety of ourselves and fellow crewmembers onboard.
- Focus on the need for barriers on worksites to prevent personnel from entering.
- Focus on housekeeping- collect tools and equipment if not working at site.
- Vessels to ensure all crewmembers have completed the mandatory safety training.
- Upon completion of the recommended actions, vessels are to ensure it is recorded for implementation.

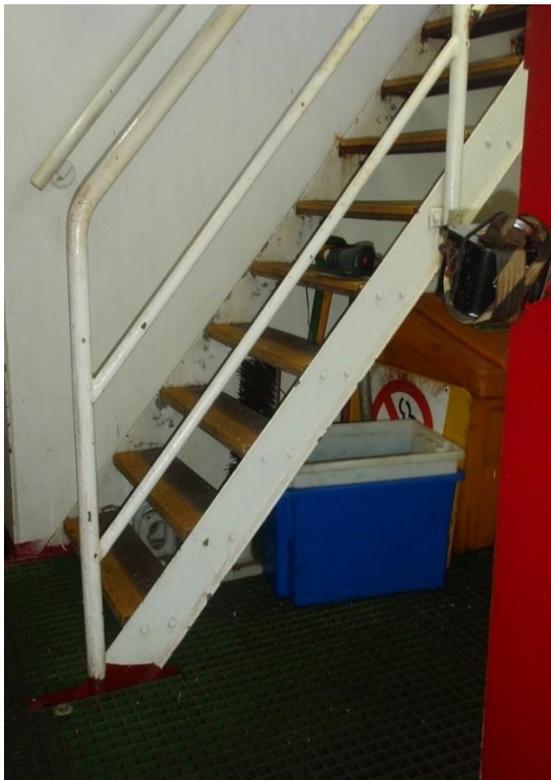
While a crewmember was transiting down a stairwell, he became aware of the hazards on the step i.e. laminated check sheets and a heat gun (heat gun sitting atop both sheets) but while he tried to avoid the hazard he's foot came in contact with the hazards at the same time. Unfortunately the crewmember slipped down to the bottom of the stairwell. The IP (Injured Person) sustained lower back injury as a result of the slip.

Photo 2 – Position of the hazards on the 5th step tread from bottom.

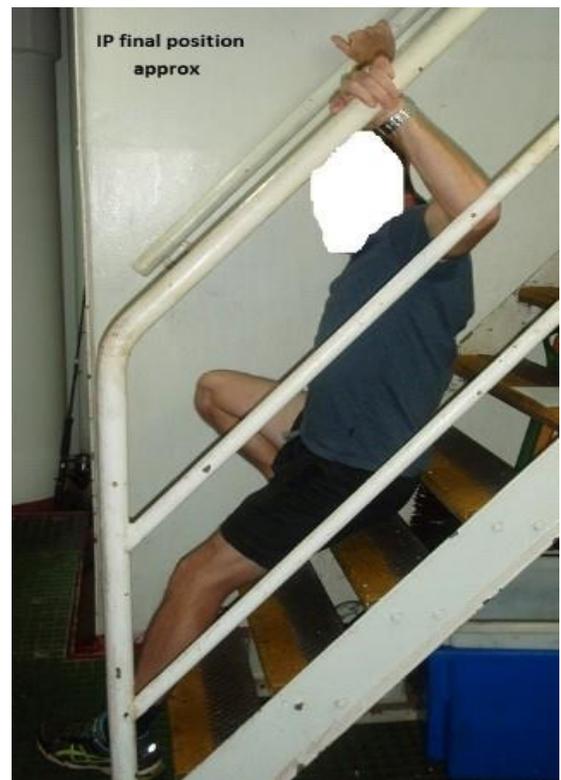
Photo 3 – IP's final position as he's
