# Marine Safety Flash

## A16-26 (15<sup>th</sup> July)

### Bilge cover left open

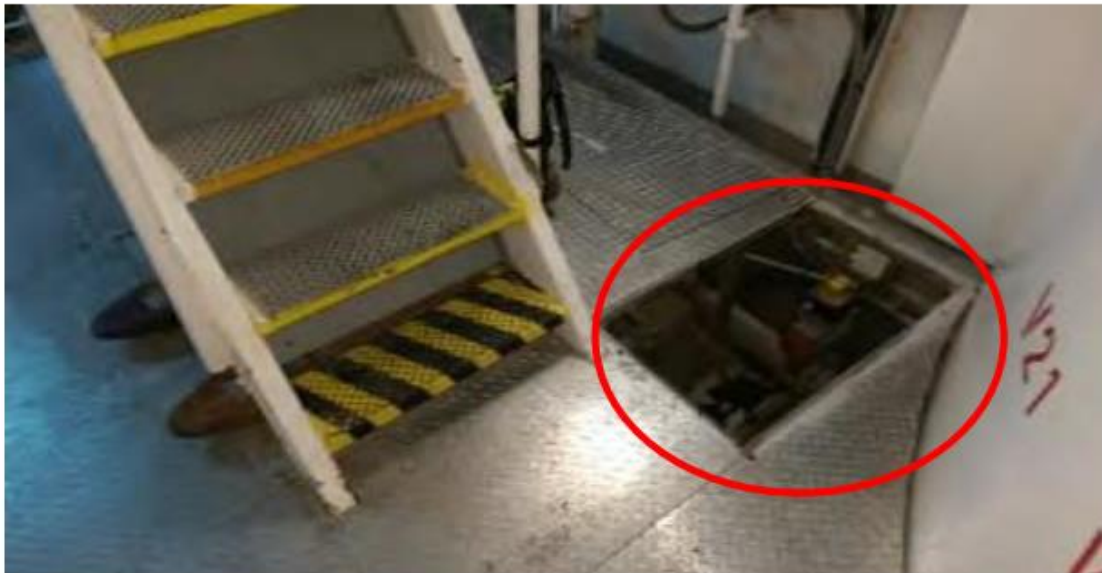
The industry member has reported an incident in which a bilge cover was left open. During a routine walk around the vessel, crew noticed in the engine room that a bilge cover had been left open. There was no barrier or signage in place.

On investigation, the bilge cover had been opened to permit brine pump maintenance work. This work had been interrupted and the employees had left the job, putting in place no safety precautions, but with the intent of returning later.

- “ Stopped the job: the opened engine room bilge covers were closed and returned to a safe condition;
- “ A safety stand down was conducted with focus on maintaining and following the correct control of work procedures.

- Maintenance processes in the engine room should be planned, all risks assessed with further implementation of control measures where needed;
- Any openings or potential trip hazards should be controlled to ensure any risk is as low as reasonably practical;
- There should be effective supervision at all times;
- Vessel crews “not learning the lessons” – further effort required to address this.
