# Marine Safety Flash

## A16-33 (14<sup>th</sup> September)

### Near miss during preparation to load anchor chain

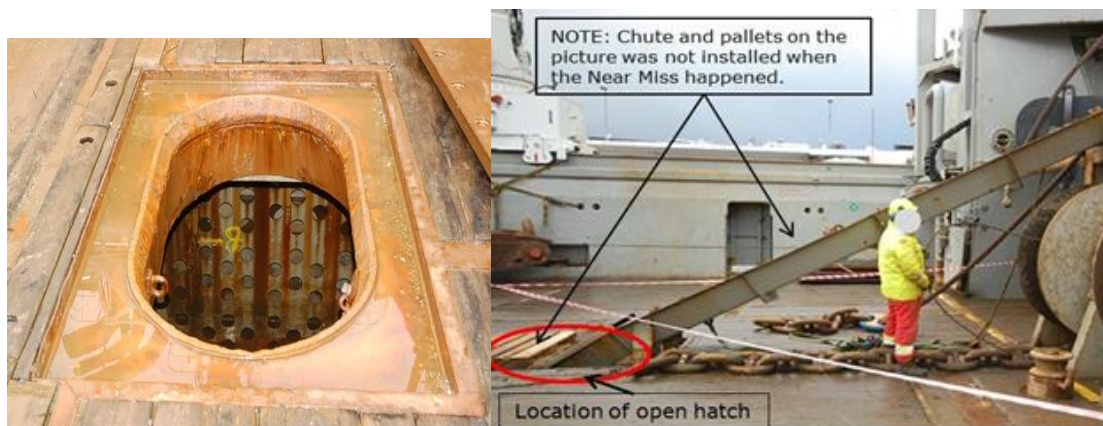
During preparation to load anchor chain into the moon pool locker, one person almost fell into the chain locker. The hatch cover had been temporarily removed prior to the installation of the chain guide. The hatch had an opening of 155 x 85 cm. The depth of the locker was approximately 10 meters and there was 1 – 1.5 meters of water on the bottom.

The person fell backwards, with the upper part of his body towards the opening of the hatch. He managed to turn slightly over to his right side and grab onto the edge around the hatch opening with both hands. His ankles and the lower part of his feet were also above the edge of the hatch opening. He managed to get his right elbow over the edge. He shouted for help twice before getting the attention of his colleagues.

- The hatch was left open without a barrier
- The opening of the hatch was not sufficiently communicated
- The work was not risk assessed and sufficiently planned, based on the risks involved

Pictures of a similar hatch opening into which the person walking backwards had fallen.

- The hatch should not have been left open without a barrier
- The opening of the hatch should have been better and sufficiently communicated
- The work on deck should have been planned based on an assessment of the risks involved
