# Marine Safety Flash

## A13-01 (15<sup>th</sup> February)

### Cut Finger on Electrical Binding

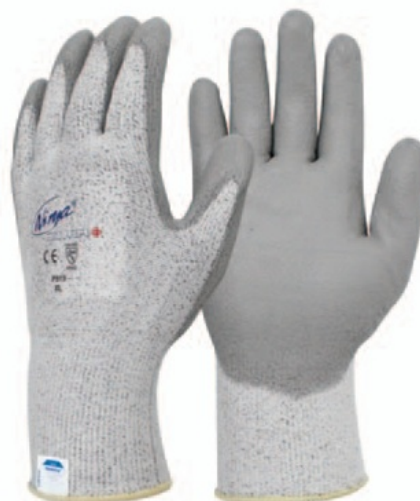
Figure 3: Gloves with cut rating 5 which are ideal for this task.

- (1) Every task will carry a degree of risk.
- (2) Prior to any task, the work scope is to be subject to a form of risk assessment to ensure controls can be put in place to minimise the likelihood of an incident. JHA for this task to be reviewed and updated.
- (3) Appropriate PPE should be worn depending on the outcomes of risk assessment.
- (4) Inherent hazard presented by stainless cable ties to be recorded in inherent hazard log and included in crew induction.
- (5) Control method for this risk is use of on-board PPE and crew are to be refresher trained on available gloves.
- (6) Feedback to be provided to vessel new build electrical superintendent regarding identification and elimination of this hazard for future vessels at new build stage.
