Marine Safety Flash

A13-14 (15th October)

Falls Into Water Whilst Boarding Vessel

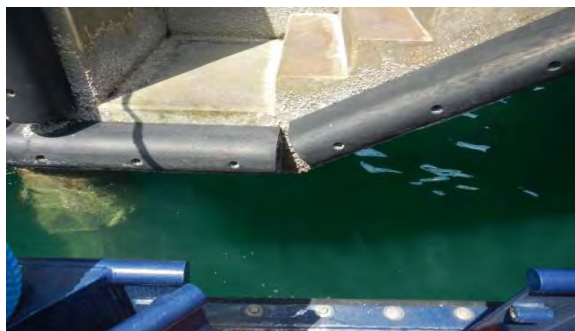
A person fell into the water while attempting to board a vessel, which was moored at a jetty.

The person was wearing an inflatable lifejacket and PPE. The person did not see the gap between the vessel and the berth and fell into the water. The lifejacket inflated and the person was recovered from the water by the crew, without severe injury.

- Proper boarding arrangements were not in place
- There was an open area between the vessel and the jetty
- There was no artificial lighting covering the boarding area

- Establish safe boarding arrangements, including adequate lighting after sunset
- Ensure the vessel is alongside at all times and mooring ropes are not slack
- Review the Risk Assessment for vessel access / egress to capture hazards and measures to be implemented to avoid a reoccurrence of the incident
- All crews to carry out a man overboard drill and assess if they have the right equipment in place to effect a recovery
- All crews be briefed immediately by the local HSE representative
