Marine Safety Flash

A14-02 (15th February)

Angle Grinder Injury

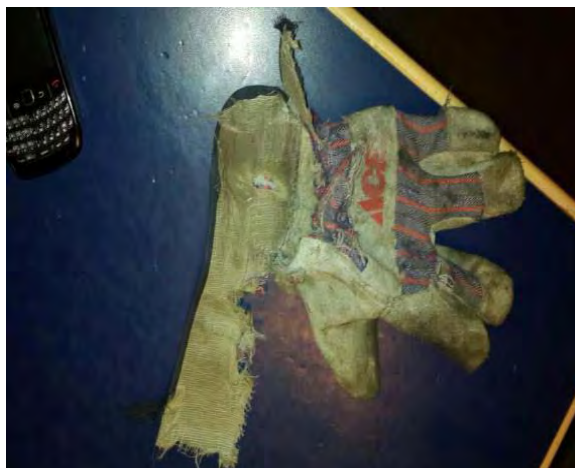
A crewmember was using an angle grinder on a winch when the cup brush hit a nut, it kicked back causing the brush to get entangled in the glove and coverall sleeve of the crewmember.

The grinder was not fitted with automatic stop (dead man button) therefore his co-worker had to step in to switch off the power to the grinder.

The crewmember suffered minor wounds only on arm and hand, but the consequences could have been severe or even fatal.

- The angle grinder was supplied without proper dead man button/cut off.
- A risk assessment at the point of work could have identified the missing safety feature on the hand tool.

- Unsafe angle grinder was removed from service on board.
- Angle grinders and other rotating power tools were checked to ensure they were fitted with automatic cut off devices.
- Crews were instructed in checking and correct use of power tools.
- Hand held power tools include angle grinders, disc sanders and chipping equipment etc. to be used must be fitted with automatic cut off devices.
