Marine Safety Flash

A15-01 (15th February)

Snake Swivel Parted during Lifting Operations

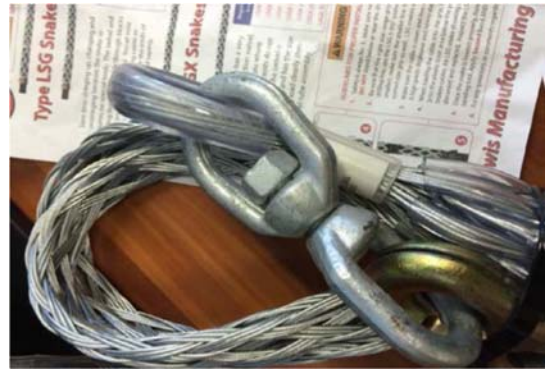
The swivel on the 'snake' that was attached to the cable failed at a height of 28 meters allowing the MRT cable (weighs over 18Kg per meter) to fall to the deck.

Lewis Snake Swivel

- Work stopped, area was made safe and investigation is underway.
- An alert for local distribution with guidance to use alternative methods for lifting heavy cable where practicable was prepared.
- Users should confirm effective exclusion zones are in place and Lewis Swivel Snakes are checked for valid certification and visually inspected by a competent person prior to use.
- Once the investigation is complete, a further alert or bulletin will be issued if appropriate.

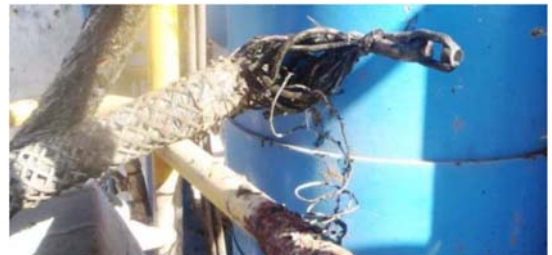
Lewis Snake

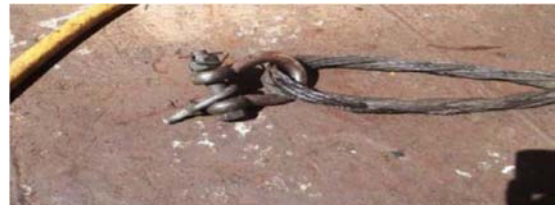
Lewis Snake swivel that parted
