Marine Safety Flash

A15-06 (15th March)

Fuel Bunker Operation

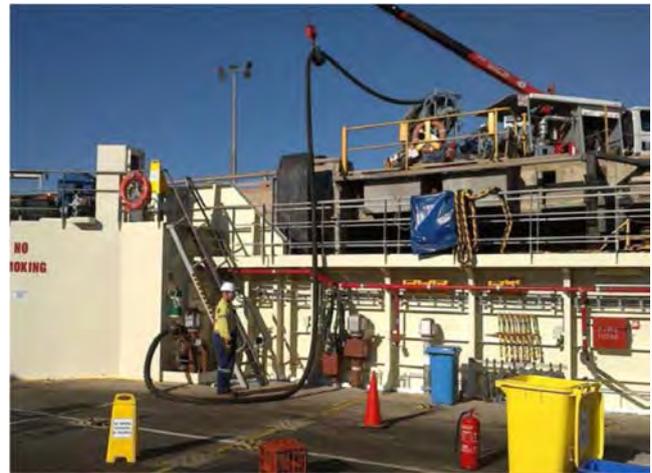
Investigation revealed that there was undetected residual pressure of 3.5 bars in the receiving ship pipelines. The pressure had been inadvertently “locked in” to the pipes following a previous fuel transfer operation some days before. The receiving ship opened their manifold and inadvertently released the pressure into the hose. The rapid release of pressure caused the hose to stiffen and “jump”, however the hose and couplings remained intact.

Hose set-up for vessel bunkers

The bunker procedures were unclear about valve line up and order of opening. The procedures have now been updated to ensure that the receiving ship bunker lines are open to the receiving tanks and at atmospheric pressure prior to opening the manifold valve to the bunker hoses.
