# Marine Safety Flash

## A15-11 (15<sup>th</sup> June)

### Marine Asset Damage

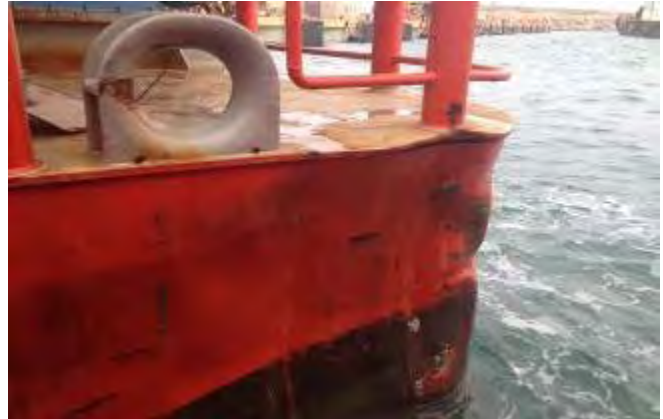
An Anchor Handling Tug (AHT) was completing cargo operations whilst in Dynamic Positioning (DP) mode. The operator then changed from DP to Joy Stick Auto Heading (JSAH) mode to commence departure. Upon engaging the JSAH the AHT experienced an unexpected and uncontrolled astern movement resulting in the AHT's port quarter and stern roller making contact with the port quarter of an Accommodation Barge. This contact resulted in damage to the Accommodation Barge's port aft quarter including a hull breach at deck level.

View of the damage sustained to Accommodation Barge due to contact with stern roller of AHT showing hull breach at deck level.

- Master of the AHTS resumed manual helm control to manoeuvre the Vessel to a safe location and access the situation.
- AHTS Master communicated incident to Barge Master of Accommodation Barge and asked to inspect and assess damage.
- Both Masters confirmed nil loss of water tight integrity that would put either vessel at risk
- Stakeholders initiated investigation.

- Have audit and assurance processes been conducted and have they verified Vessel is classed and authorised for DP operations?
- Are Operators trained with current certification to operate in dynamic positioning mode?
- Are hazards associated with DP operations identified and effectively mitigated to ALARP?
