Marine Safety Flash

A15-25 (15th October)

Chain Chute

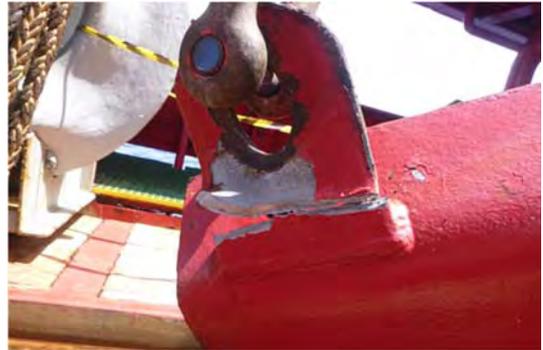
During vessel operations after a chain recovery operation, the port chain chute had to be restowed temporarily to lift the port aft chain locker lid back into the secured position. 2 x IR's (AB's) were involved in lifting the chain chute with a certified and inspected 7t shackle and the port rail crane. When at the height of the lift, the lifting lug failed on the port chain chute causing it to fall back onto the main deck.

Lifting lug with shackle

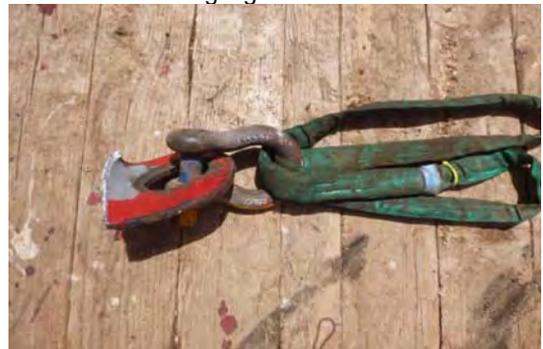
Damaged lifting lug

1. The chain chute was lifted and raised into position by the crane operator using the hoist function of the wire, and by extending the lower jib arm to provide forward momentum to position the chute into the stowed position.
2. When the chute was vertical, the operator continued extension of the jib to house the chute without lowering the crane wire and because the lifting point reached the limit of its fulcrum, this increased vertical tension on the wire thus overloading it and caused the lifting lug to fail as it was the weakest link.

1. On-board familiarisation and competency assessment carried out for any operator prior to being assessed as 'competent' to operate any deck cranes. This is to include the hazards and controls around a vertical lift with a static object at a critical point of the operation.
2. Consider alternative lifting arrangement for this operation (Remove lifting lug and replace with 2 x holes through the sides of chute where appropriate lifting slings with shackles can be used).
3. Review and discuss this incident with all relevant crew on board at next Safety Meeting.
