Marine Safety Flash

A15-30 (15th December)

Hydraulic Oil in Face

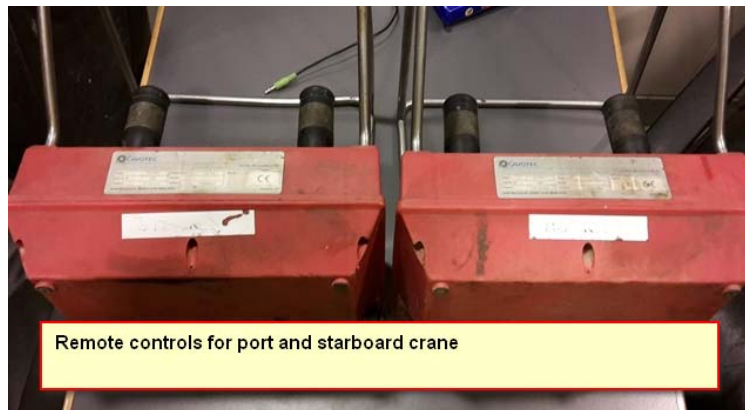
The incident happened on one of our vessels, when moored in harbour. An Engineer was changing a manometer fitting on the crane. When they disconnected the fittings, the crane was started and the engineer was sprayed with hydraulic oil under pressure in their face (pressure in system is 10 bar).

- Crane was had not been switched off (isolated) on switchboard
- Permit To Work (PTW) not completed
- Engineer informed the AB's about work in crane when passing them in the mess
- AB started wrong crane with remote control
- Personal Protective Equipment (PPE) was in use by all personnel involved
- Engineer was given first aid and sent to the hospital ashore for medical check-up and was cleared to return to work, the engineer was given ointment to put on for any future irritation

1. PTW system is to be used on jobs such as working at height/electrical/hydraulic components
2. Switch off crane on switchboard before work and tag the switch/controls
3. Remarking of remote controls labels if worn out
4. Full eye and face protection (splash shield) to be used when working on pressurised hydraulic system
5. Crane familiarization to be conducted by all personnel before using the cranes
6. A safety meeting with all relevant personnel to be conducted
