# Marine Safety Flash

## A16-29 (16<sup>th</sup> August 2016)

### Electrical burn out and potential fire

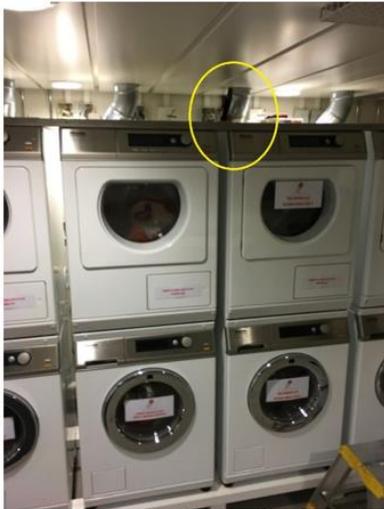
Fig. 1 Arrangement of washing machines (Lower) and Dryers (Upper). Location of fire highlighted.

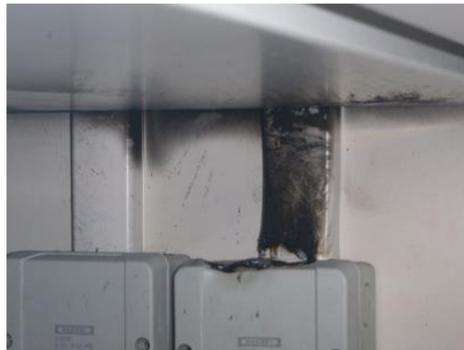
Fig.2 Detail view of fire damage to Junction Box and cable conduit.

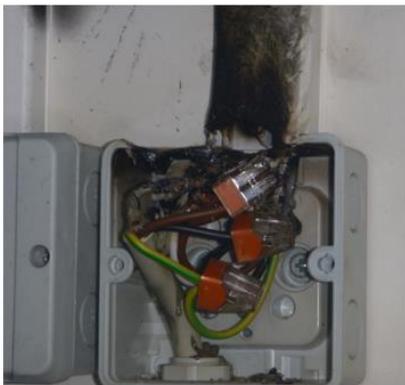
After the location was confirmed as safe the ETO commenced opening the junction box open and the other boxes in the laundry to investigate. It was found that the WAGO connector on one phase of the 440V supply cable for the Washing Machine had burnt out.

Fig. 3 Detail view of internals of burnt out Junction Box for washing machine No.2

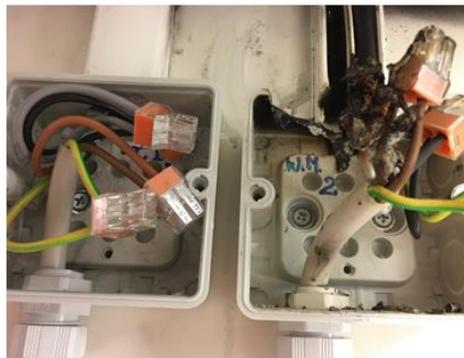
The fire was caused by the incorrect application of a WAGO push wire connector. The connector is for rigid cable only and is not suitable for the flexible fine stranded power cable of a washing machine. When flexible cables are fitted to PUSH WIRE connectors, due to the flexibility of the fine strands, the wire cannot be pushed properly into the spring loaded fitting. The resultant reduction in effective wire conductor area at the connection in this case caused overload and subsequent heat generation resulting in fire.

Fig. 4 Detail view of internals of burnt out Junction Box showing failed connector.

The recommended connector for flexible cable is a screwed terminal block.

1. Discuss the use of WAGO/push type electrical connectors at your next safety meeting. (Include the potential consequences for using equipment outside of specifications)
2. Include the use of WAGO/push type electrical connectors within all Engineering Handover notes for discussion and information.
  - Specifically the use of such items should be strictly used within the design requirements of the equipment listed within the specification.

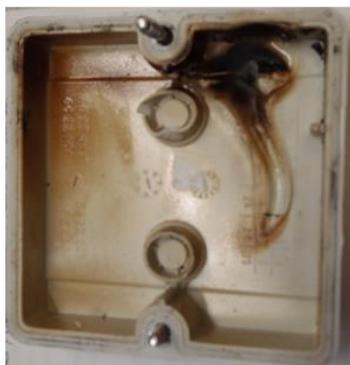
Fig. 5 Lid of Junction Box for Washing machine 4 showing evidence of previous heat damage

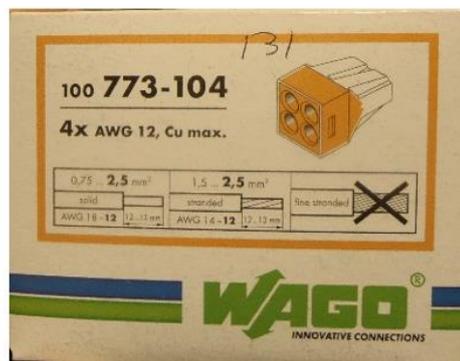
Fig. 6 Top cover of WAGO PUSH WIRE connector box. Note clear instruction that connector is not permitted for fine stranded flexible wire.
